<b>Wulfsberg Electronics</b> <i>A Chelton Group Company</i>	
<b>APPROVALS</b>			
DRAWN	R. Durall	4-4-05	<b>TITLE:</b> <b>SERVICE BULLETIN WSB IDU-III-15</b> <b>(SOFTWARE APPLICATION VERSION 5.0B)</b>
CHECKED	D. Boston	4-4-05	
PRODUCT MANAGER	---	---	
ENGINEER	R. Durall	4-4-05	<b>SIZE</b>

## SERVICE BULLETIN

**EQUIPMENT:** IDU-III

**BULLETIN NUMBER:** WSB IDU-III-15 Revision C

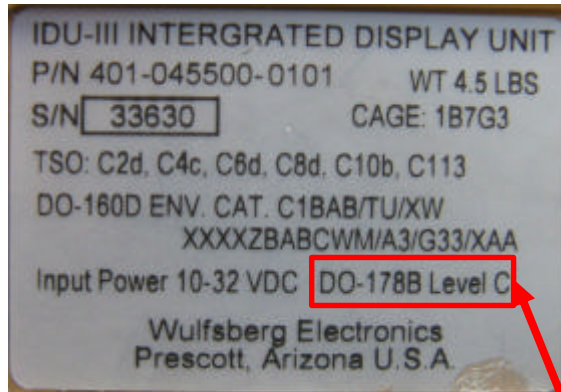
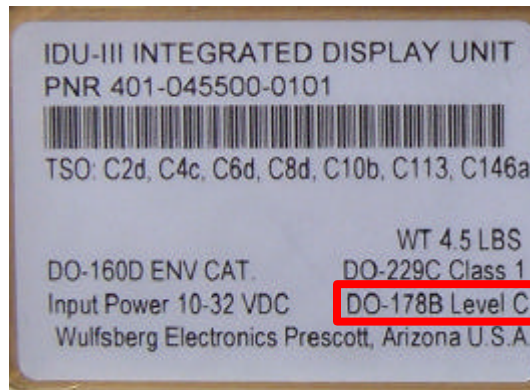
**Figure 7 Original ID Label**

4. If either label contains the statement "DO-178B Level C", remove the statement using a black felt pen with permanent ink (see **Figure 7** and **Figure 8**).

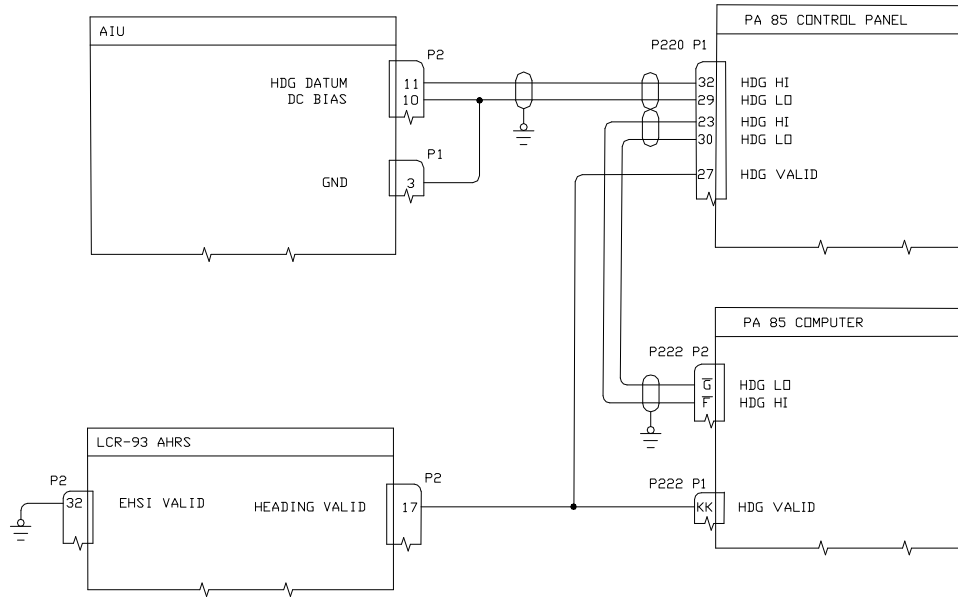
**Figure 12 Old EFIS to Sfim PA-85 Wiring Diagram**

Rotorcraft with the EFIS interfaced to a Sfim PA-85 autopilot under Chelton STC SR02209AK or SR02230AK must modify the wiring as follows using Figures 12 and 13 below:
