<b>Wulfsberg Electronics</b> <i>A Chelton Group Company</i>	
<b>APPROVALS</b>			
DRAWN	R. Durall	4-4-05	<b>TITLE:</b> <b>SERVICE BULLETIN WSB IDU-III-15</b> <b>(SOFTWARE APPLICATION VERSION 5.0B)</b>
CHECKED	D. Boston	4-4-05	
PRODUCT MANAGER	---	---	
ENGINEER	R. Durall	4-4-05	<b>SIZE</b>

## SERVICE BULLETIN

**EQUIPMENT:** IDU-III

**BULLETIN NUMBER:** WSB IDU-III-15 Revision C

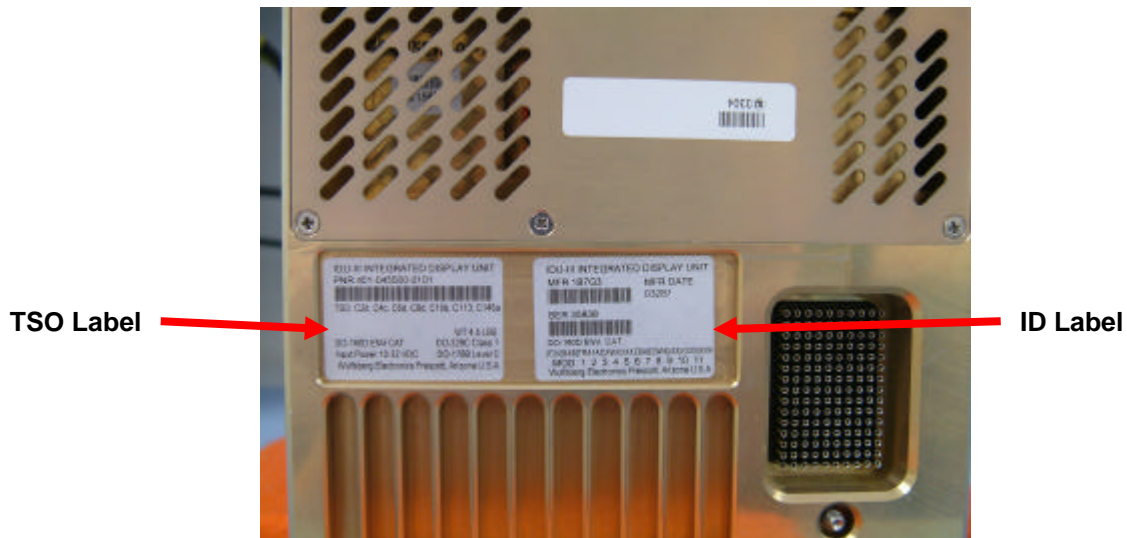
Figure 6 IDU Rear View

**NOTE:** ID Label and TSO Label may be in opposite locations depending on manufacturer's application.

3. Locate the IDU-III TSO Label and the ID Label on the back of the IDU (see **Figure 6**). Early production IDUs were manufactured with an ID label style shown in **Figure 7**.

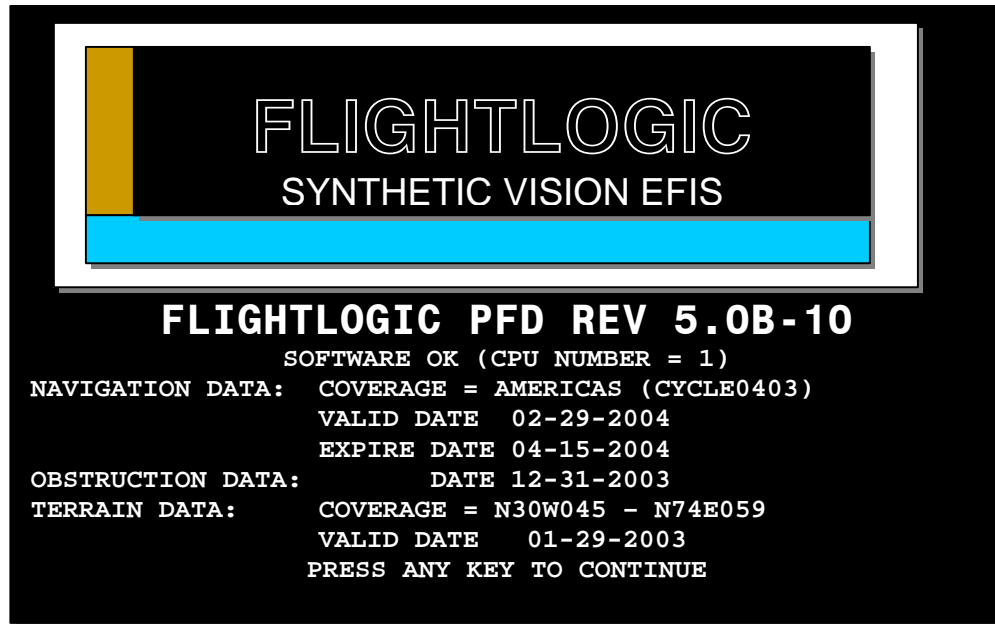
**Figure 11 Typical EFIS Status Page**

**NOTE:** PFD/MFD and CPU Number will depend on the position of the IDU.

1. Apply power to the EFIS system and verify each IDU completes initialization and testing.
2. Verify the information listed below is displayed on each modified IDU status page (See **Figure 11**):
  - a. "Rev 5.0B-10"
  - b. "SOFTWARE OK"
